## CARBONATATION FIBER CEMENT BOARD

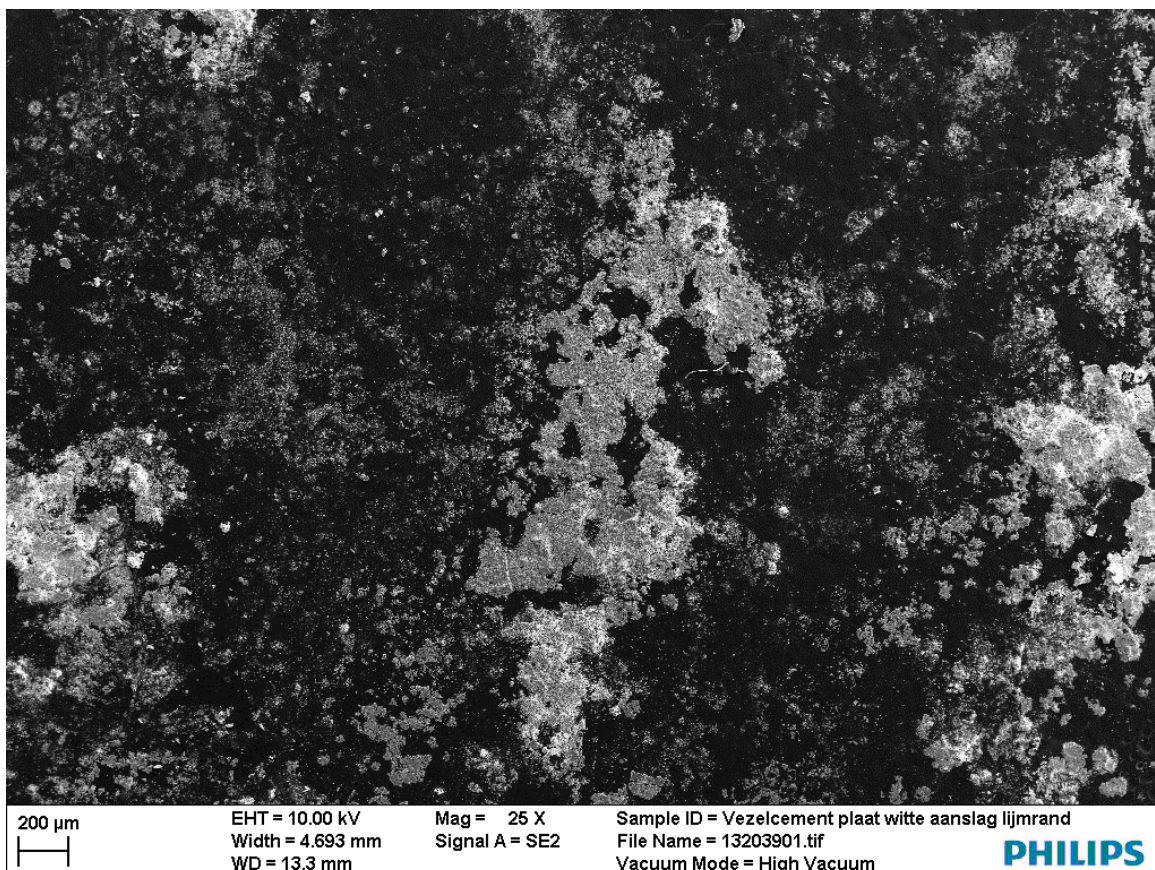
After applying the fiber cement façade panels, the cement the fiber cement panels will continue to curing, due to influence of Carbon Dioxide ( $\text{CO}_2$ ) the molecules in the cement of calcium-hydroxide  $\text{Ca}(\text{OH})_2$  is converted to calcium carbonate ( $\text{CaCO}_3$ ). Due to this process water will be released. This so-called carbonization process is accompanied by shrinkage of the plate.

This chemical reaction will expedite as the plate becomes more in contact with carbon dioxide ( $\text{CO}_2$ ).

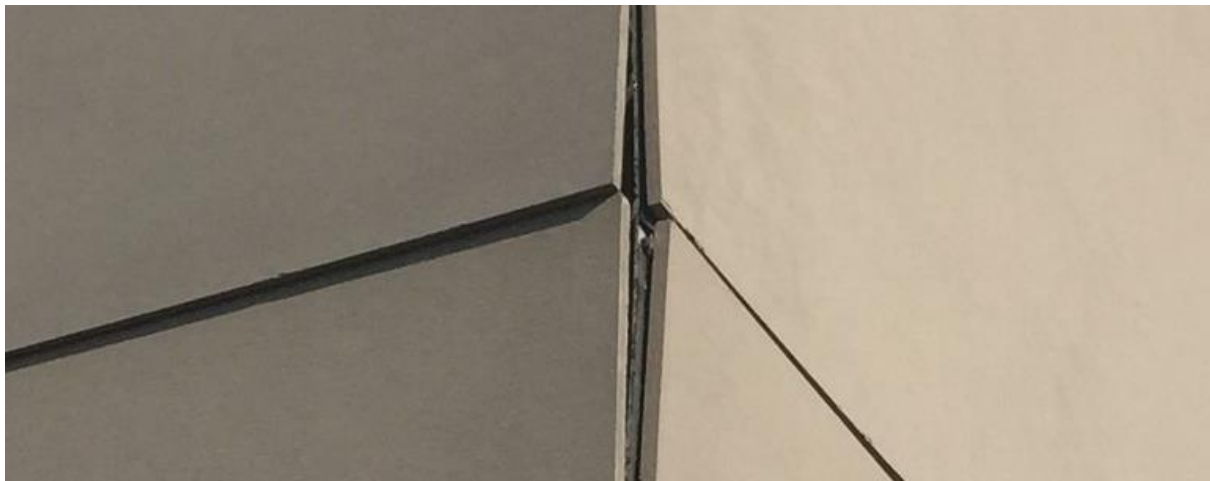
In the event of insufficient ventilation, the combination of the above-mentioned conditions enhances the defined reaction whereby a permanent curvature of the fiber cement panel occurs in both the width and the height of the panel.

The stresses that occur are reflected in the “curling of the ears” of the façade panel. As a consequence, there is a permanent tensile stress on the glue joint, eventually resulting in an adhesive fracture and / or delamination of the glued substrates located at the corner(s) of the façade panel.

However the carbonatation process of fiber cement panels needs attention. When the panels are not completely dried a thin layer of calcium carbonate  $\text{CaCO}_3$  (see attached photograph) forms itself at the backside of the panel which may form a brittle layer difficult to bond on.

We can therefore conclude that the ventilation conditions, especially for façade cladding with fiber cement panels, require a lot of attention.

Regarding carbonatation of fiber cement panels we need to emphasize bonding these kind of panels with a pre-treatment on the surface where you put your adhesive bead with TWEHA Prefix X-tra is functioning without any problem.
