## LET THE JOINTS BE OPEN! DO NOT USE A JOINT PROFILE!

For many years TWEHA advises to omit the use of joint profiles in combination with more or less porous materials, such as natural stone or cement fiber panels.

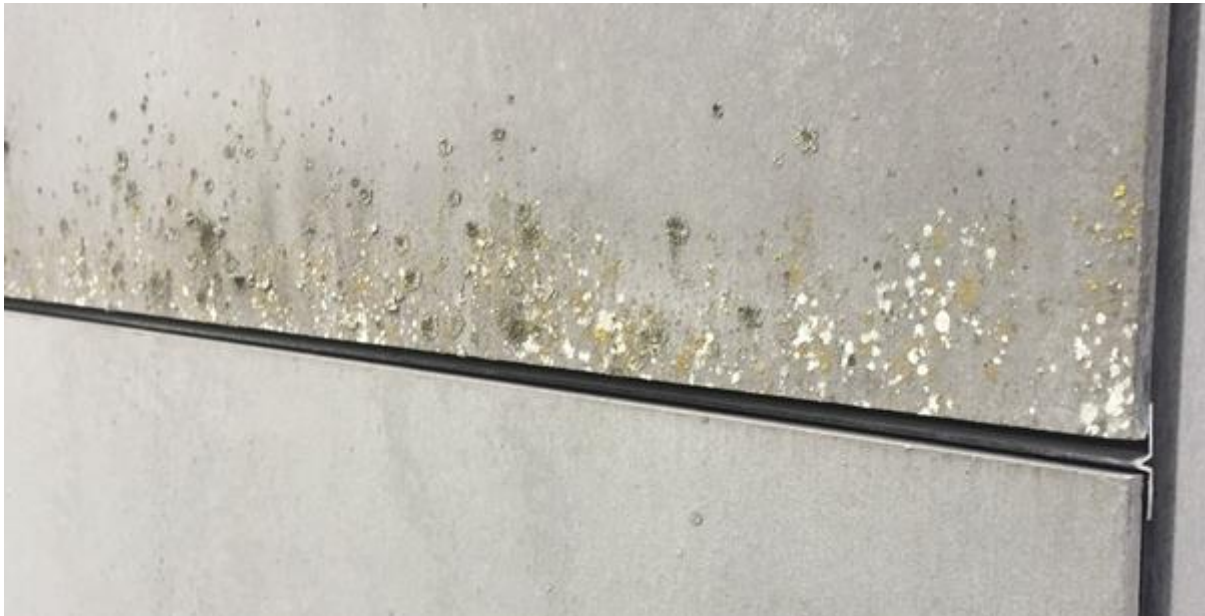
Despite our advice and experience, a joint profile still seems to be applied regularly. There will be capillary action or suction of (rain)water in the narrow space between the cladding and joint profile. As a result of which the porous façade sheets will continually come into contact with water and at long last will fill up with small amounts of water.

Resulting in fungal growth, green deposits and crumbling edges are the result. The use of a joint profile is a cause for this phenomenon. A knowledgeable installer knows that the application of a joint profile must be avoided and therefore will strongly advise you to omit the application of a joint profile. In case of open joints, you really do not have to worry about the moisture management in your façade construction provided that the air cavity behind the cladding is sufficiently ventilated. In the event of a rain shower, the largest amount of rainwater is discharged along the façade surface. As a result of the negative pressure in the air cavity, the small amount that still penetrates through the open joint is discharged at the rear of the façade panel. In case of insufficient ventilation, due to temperature differences inside and outside the air cavity, condensation can also occur at the rear of the façade panel.

A permanent air circulation in the air cavity ensures that this environment dries up quickly. The open joints contribute to a fast and even process of drying and it ensures that moisture can be removed fast, which significantly reduces the chance of contamination of, for example, moss or fungal and algae growth.

Studies show that the moisture management in a ventilated façade construction with an open joint (8-10 mm) functions excellently.
